**Federal District Boundary Markers in Northern Virginia:
Condition and Preservation Issues**

Elaine S. McGee

Open-File Report 94-592

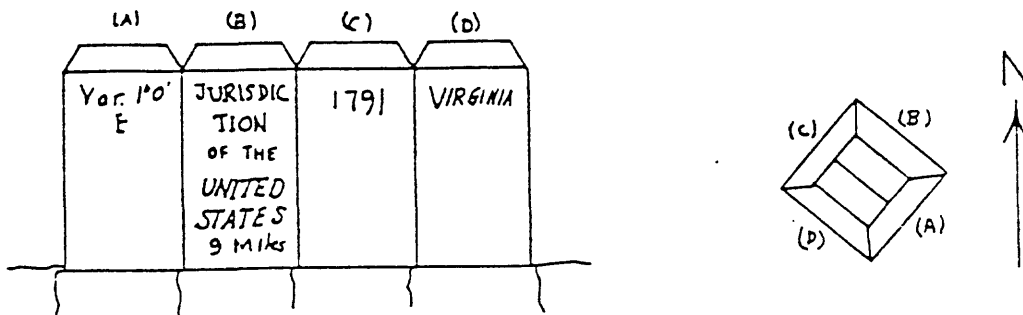
Southwest 9: Only a portion (perhaps half, but it is uneven) of the original 2 feet of this stone is exposed. The original smooth surface finish of the faces and part of the top of the stone is preserved. The inscriptions are very crisp. There are no blackened areas on the surface of this stone but there are some lichens and moss or algae present.

Figure 1. Sketch showing a view of the four sides of a standard marker boundary stone and a top view of the stone to show how it is oriented with respect to the compass directions. This particular example is the Southwest 9 marker. Each of the sides of the stone contained a standard notation: A) The magnetic variation at that location, measured when the mile marker locations were surveyed. B) This side faces the Federal Area and gives the distance of this marker from the cornerstone (in this case the Southwest Cornerstone) for which the side is named. C) The year when the stone was placed. D) This side faces, and gives the name of, the state that borders the Federal Area at this point.
